Home Inspection Report

123 Sample Street
Sampleville, FL 32328

Prepared For: Sam Sample
Inspected On Sat, Apr 27, 2024 at 9:30 AM

The Salty Inspector
(850) 583-1717
www.SaltyInspector.com

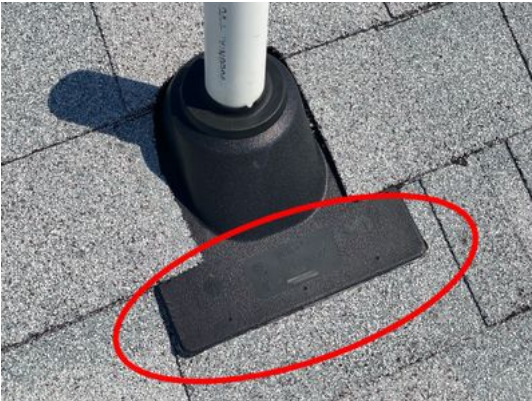
Comment 3

Roof: Plumbing Vent Stacks

The plumbing boot flashing is missing nails at the lower edge, which should be installed and sealed to reduce uplift and wind driven moisture intrusion.

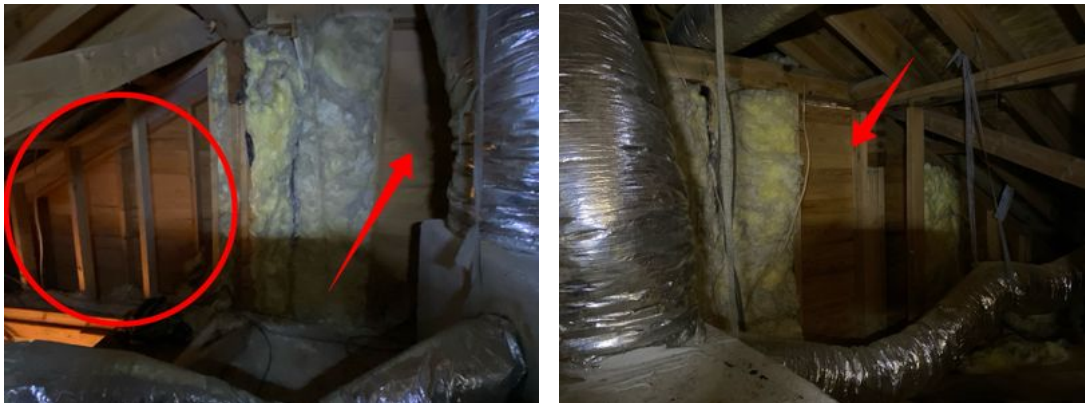
Comment 5

Attic: Observations: Insulation

Insulation on the walls of the living space is missing in several areas. I recommend the condo be addressed to restore proper energy efficiency.

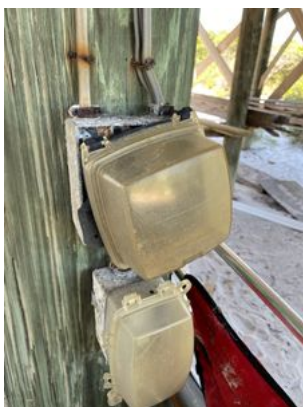
Comment 7

Exterior: Exterior Light Fixtures

The light switch cover in the raised foundation needs serviced to prevent moisture and pest intrusion.

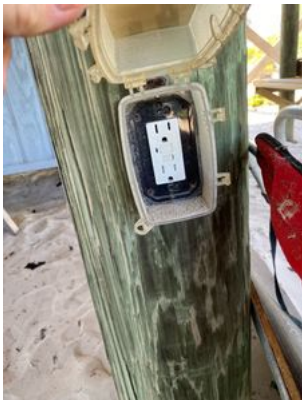
Comment 8

Exterior: Exterior Electrical Receptacles

The GFCI receptacle in the raised foundation is not functional and should be serviced.

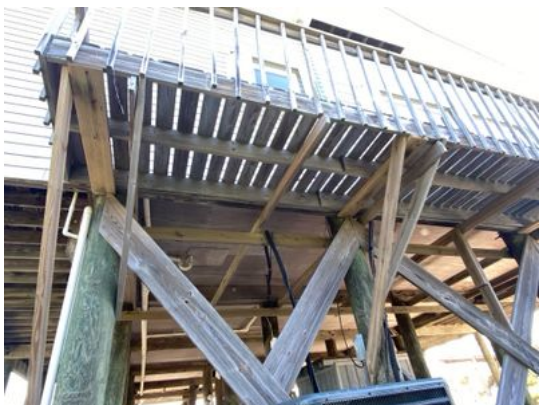
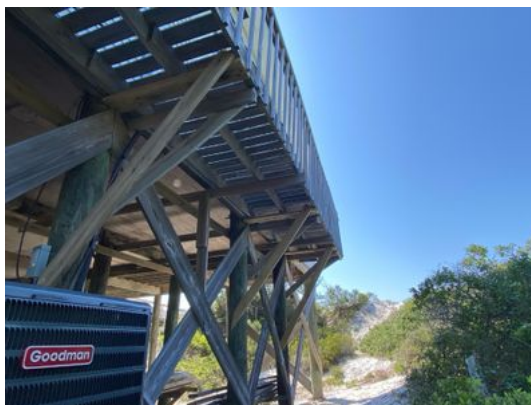
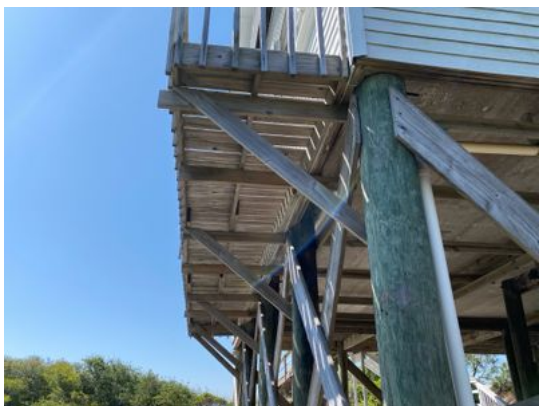
Comment 9

Exterior: Balconies & Decks

The East and West side decks/ walkways use an unusual cantilever support system, and deck plank spacing that I cannot endorse. I recommend review by a correction as appropriate, or approval in writing.

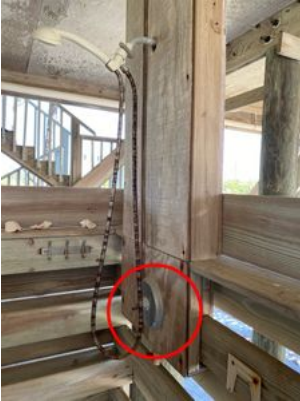
Comment 11

Exterior: Exterior Shower(s)

The exterior shower fixture has a damaged / missing handle and should be serviced to restore functionality.

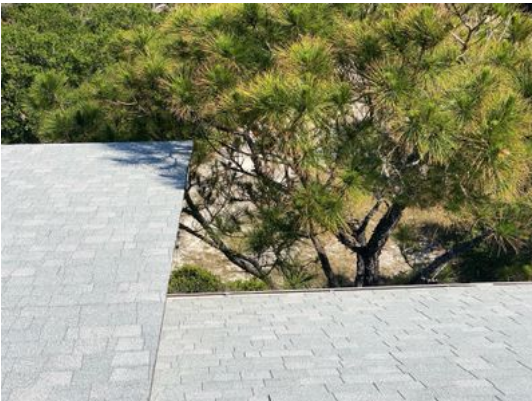
Comment 12

Site: Vegetation

I recommend the pine tree in the north east corner be trimmed to eliminate contact with the roof and inevitable damage to the roof covering.

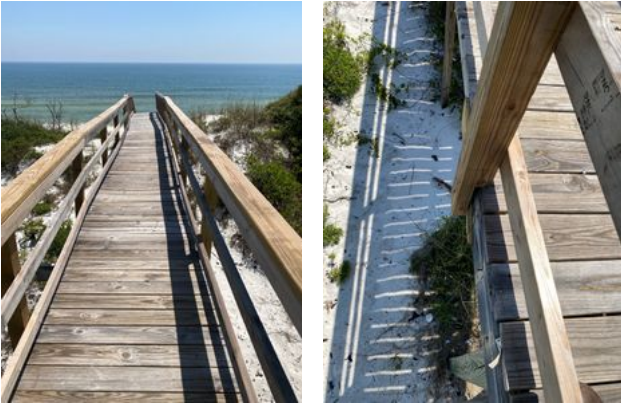
Comment 14

Site: Stairs And Walkways

The stair and walkways are in generally acceptable condition. However, the dune walkover, which is outside the scope of my inspection, is not level and square. Additionally, the railing on the dune walkover is inadequately secured and should be used with caution and serviced to ensure safe use.

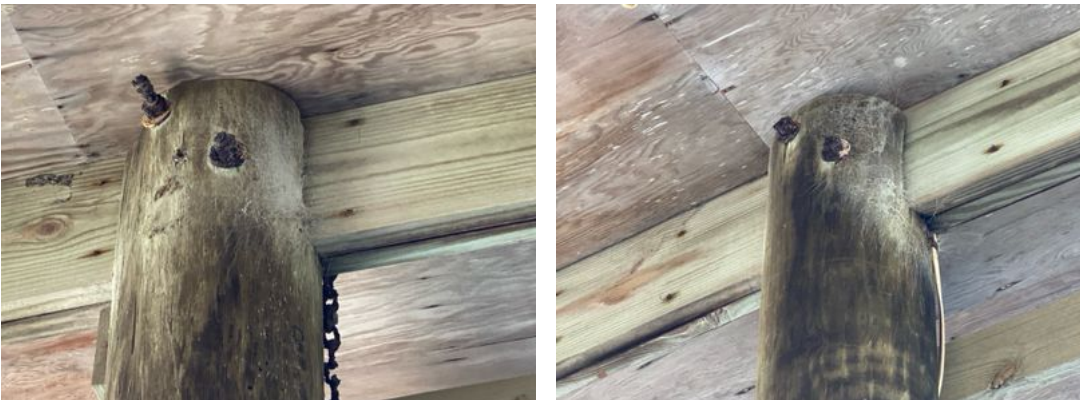
Comment 15

Foundation: Foundation Types

The foundation bolts have corrosion typical for coastal environment. To ensure continued structural integrity, I recommend review and replacement where appropriate by a licensed contractor.

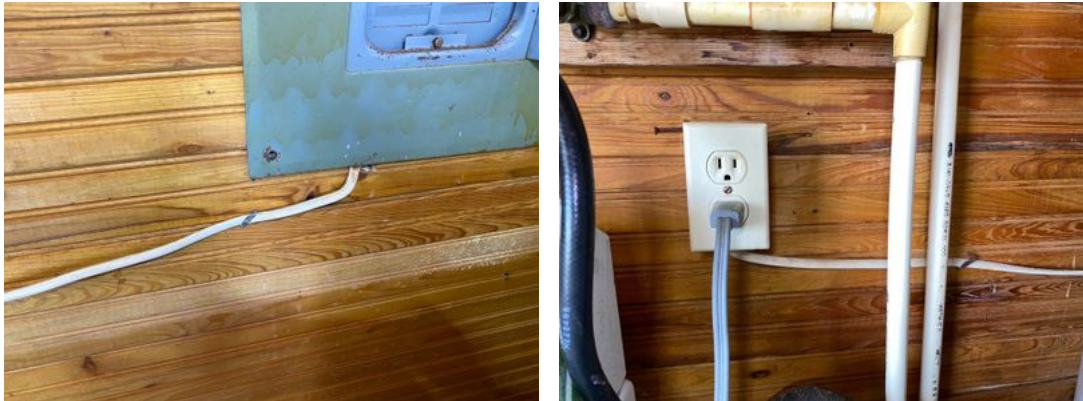
Comment 16

Electrical: Primary Sub Panel: Branch Circuit Wiring

The branch wiring to the clothes washer should be contained in conduit.

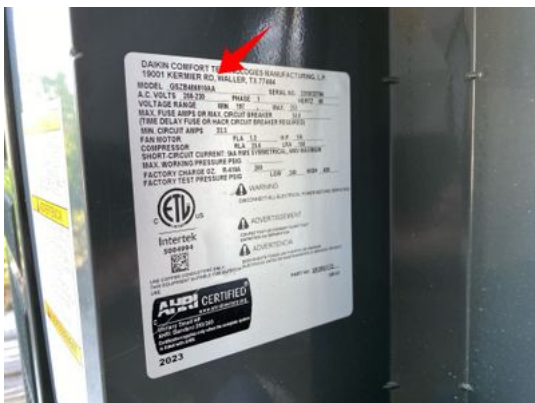
Comment 18

HVAC (Heat & Air Conditioning)

I am not qualified to calculate the size requirements for HVAC systems. However, using a rule of thumb of about 700 sq foot / cooling ton; the system installed at this home would be judged as oversized. Oversized systems can perform poorly and contribute to poor indoor air quality. Therefore, I recommend you consult with an HVAC specialist about the application and address as appropriate or approved in writing.

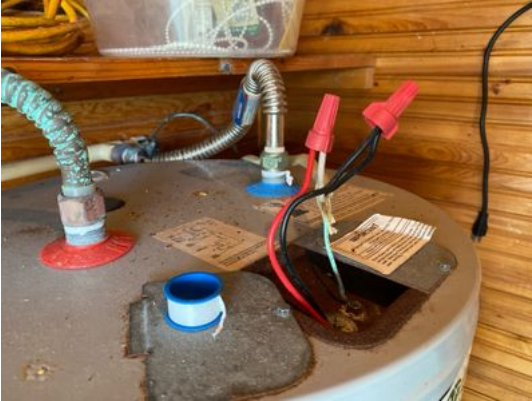
Comment 22

Plumbing: Water Heater: Fuel / Power Disconnect

The electrical connection is outside the contained junction box and should be corrected to reduce potential hazard.

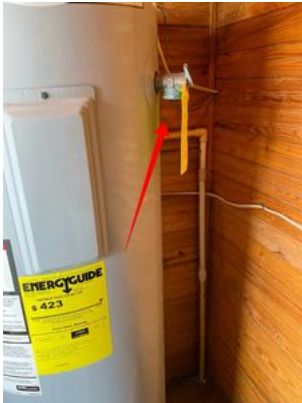
Comment 24

Plumbing: Water Heater: Temp Pressure Relief (TPR) Valve

Water heater is missing discharge line from TPR valve. The condition should be corrected by licensed plumber to manage any discharge and reduce potential damage or injury.

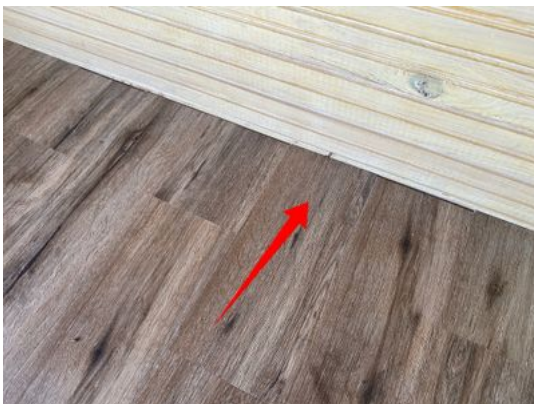
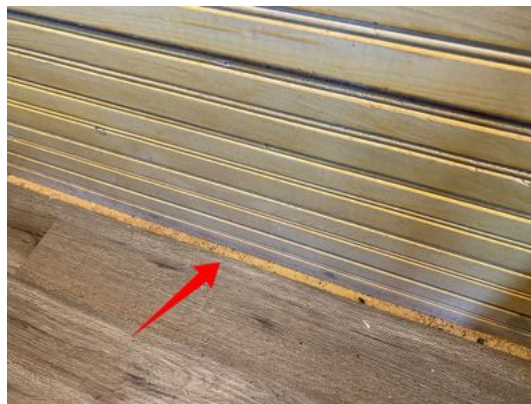
Comment 26

Interior: Floors

Quarter round trim has not been installed at the wall intersection, which allows accumulation of dirt and debris. I recommend trim be installed for hygienic reasons.

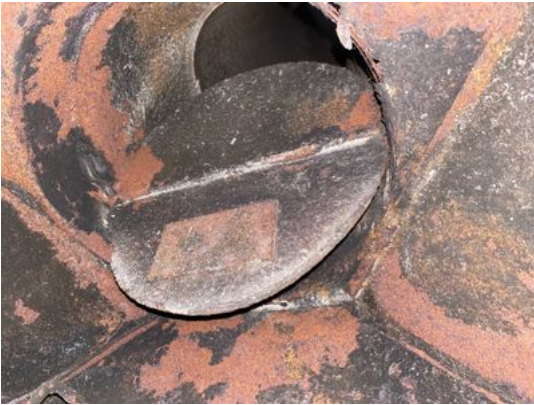
Comment 27

Interior: Fireplace

There is heavy corrosion visible on the damper and upper part of the flue. I recommend review of the fireplace by a chimney specialist and service as appropriate or approval for use in writing.

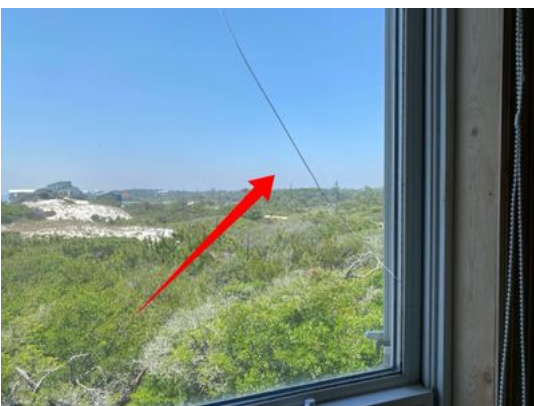
Comment 31

Bedrooms: Bedroom # Master: Windows

The upper glazed panel on the right side of the west wall is fractured and should be serviced.

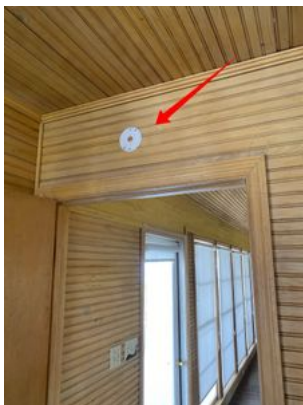
Comment 34

Bedrooms: Bedroom #SE Corner: Electrical

The smoke detector is missing in the SE bedroom and should be replaced to reduce potential fire safety hazard.

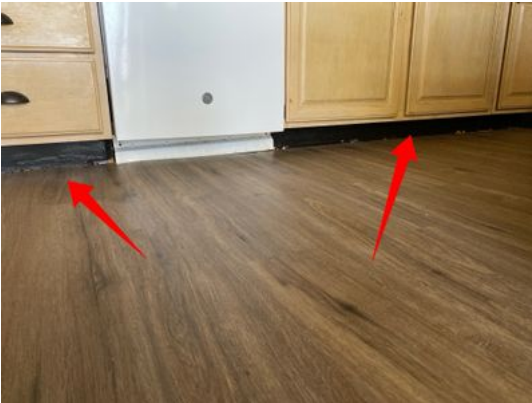
Comment 39

Kitchen: Cabinets

There was a damage to the toe plates on the cabinets. This is considered a WDO concern and should be addressed by the appropriate specialist.

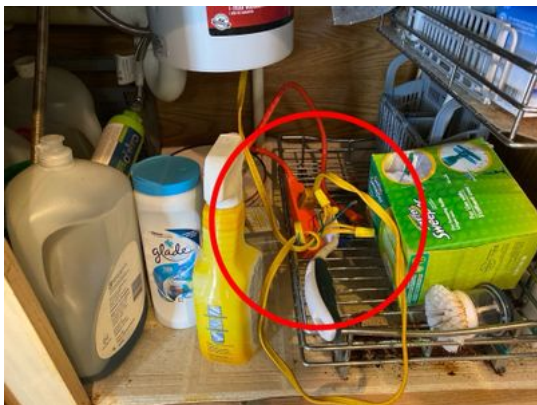
Comment 41

Kitchen: Appliances: Disposal

The disposable is incorrectly wired to an extension cord pig tail, and not plugged into power. This application should be corrected to restore proper operation.

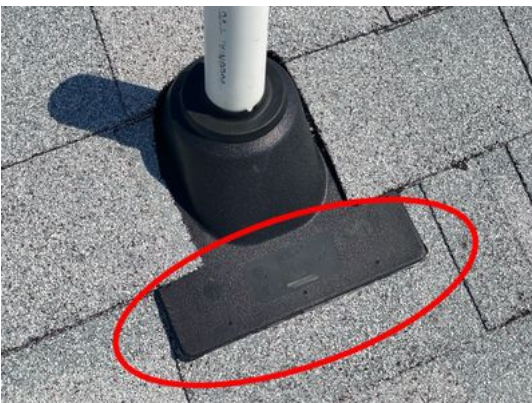
The plumbing boot flashing is missing nails at the lower edge, which should be installed and sealed to reduce uplift and wind driven moisture intrusion.

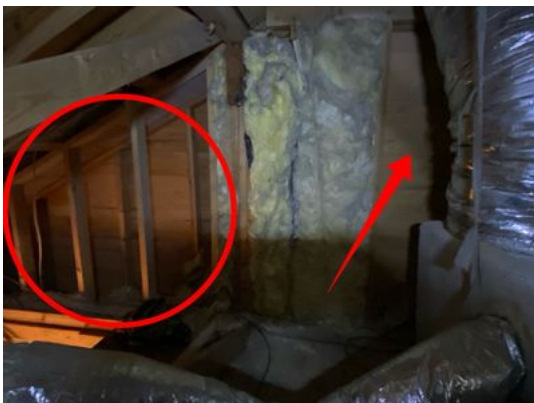
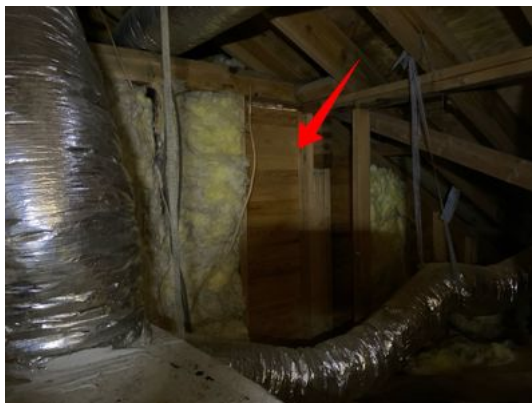
Insulation on the walls of the living space is missing in several areas. I recommend the condo be addressed to restore proper energy efficiency.

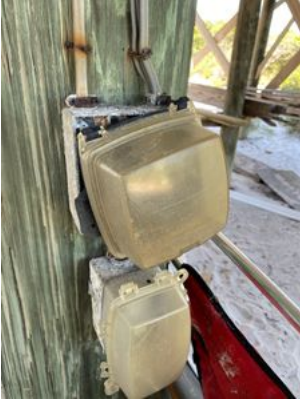
The light switch cover in the raised foundation needs serviced to prevent moisture and pest intrusion.

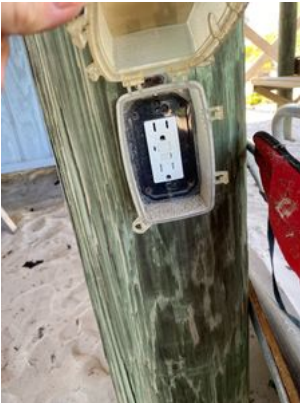
The GFCI receptacle in the raised foundation is not functional and should be serviced.

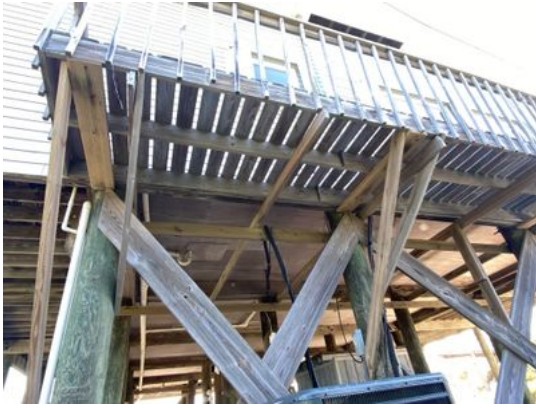
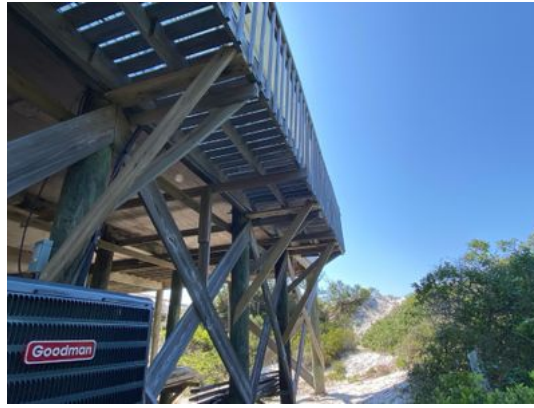
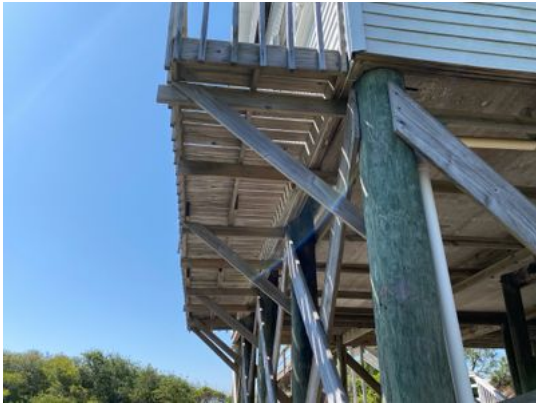
The East and West side decks/ walkways use an unusual cantilever support system, and deck plank spacing that I cannot endorse. I recommend review by a correction as appropriate, or approval in writing.

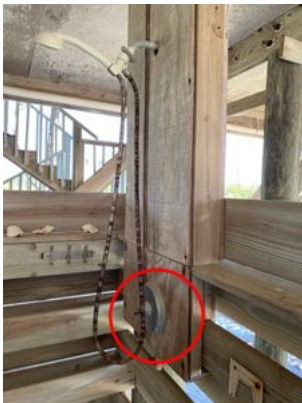
The exterior shower fixture has a damaged / missing handle and should be serviced to restore functionality.

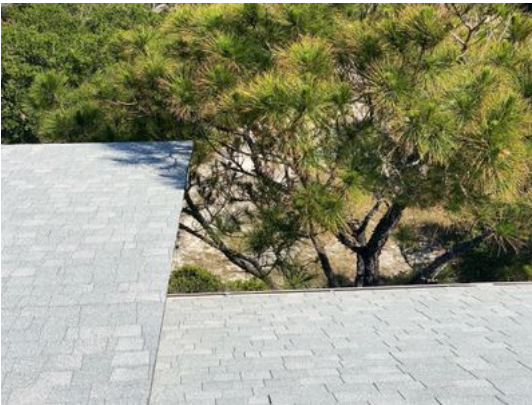
I recommend the pine tree in the north east corner be trimmed to eliminate contact with the roof and inevitable damage to the roof covering.

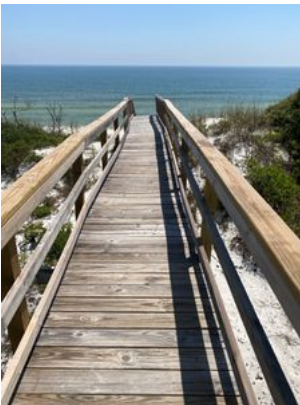
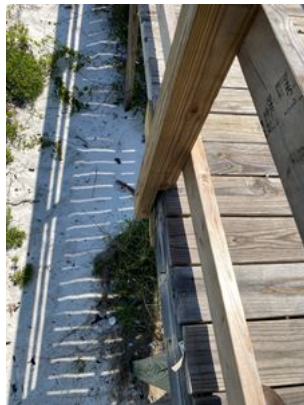
The stair and walkways are in generally acceptable condition. However, the dune walkover, which is outside the scope of my inspection, is not level and square. Additionally, the railing on the dune walkover is inadequately secured and should be used with caution and serviced to ensure safe use.

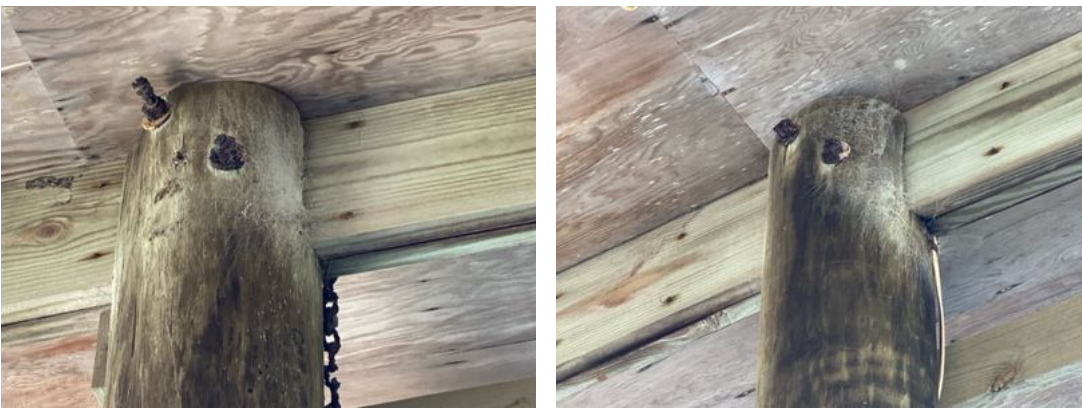
The foundation bolts have corrosion typical for coastal environment. To ensure continued structural integrity, I recommend review and replacement where appropriate by a licensed contractor.

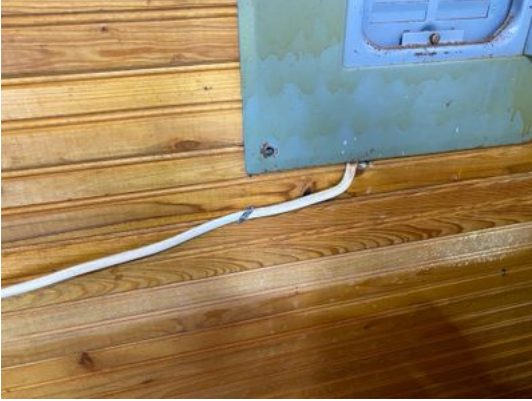
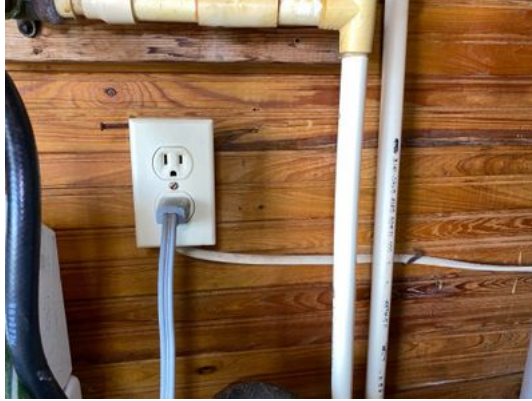
The branch wiring to the clothes washer should be contained in conduit.

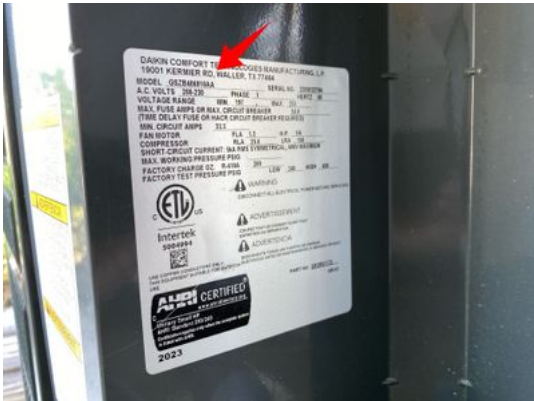
Comment 18

I am not qualified to calculate the size requirements for HVAC systems. However, using a rule of thumb of about 700 sq foot / cooling ton; the system installed at this home would be judged as oversized. Oversized systems can perform poorly and contribute to poor indoor air quality. Therefore, I recommend you consult with an HVAC specialist about the application and address as appropriate or approved in writing.

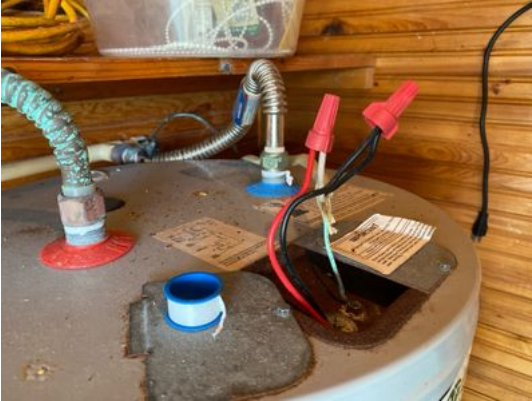
The electrical connection is outside the contained junction box and should be corrected to reduce potential hazard.

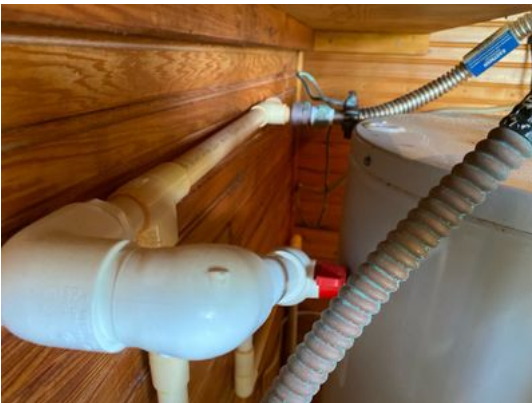
There is no water shut off valve present at the water heater, which would have been required at the time of installation. A shut off valve should be installed by a licensed plumber.

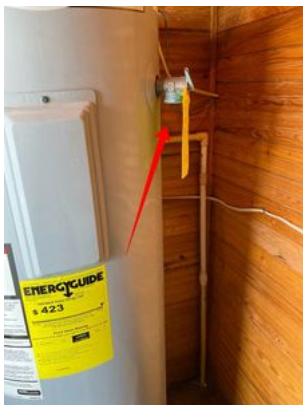
Water heater is missing discharge line from TPR valve. The condition should be corrected by licensed plumber to manage any discharge and reduce potential damage or injury.

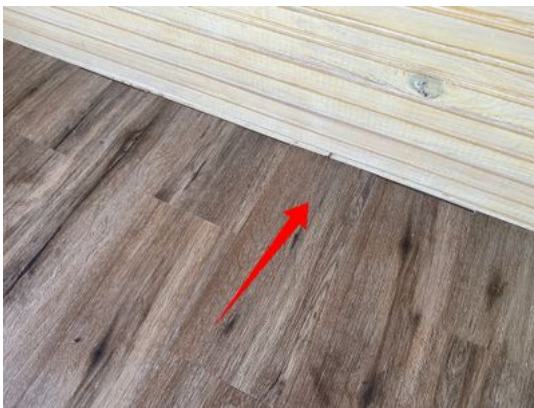
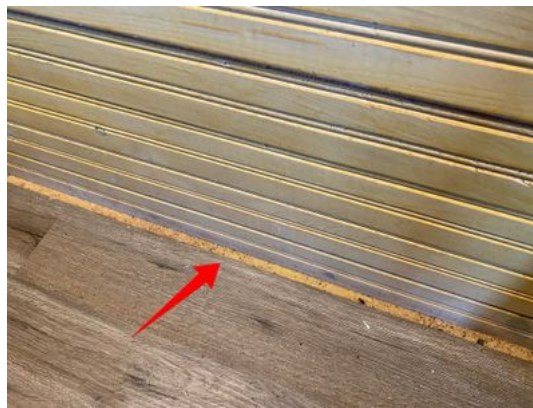
Quarter round trim has not been installed at the wall intersection, which allows accumulation of dirt and debris. I recommend trim be installed for hygienic reasons.

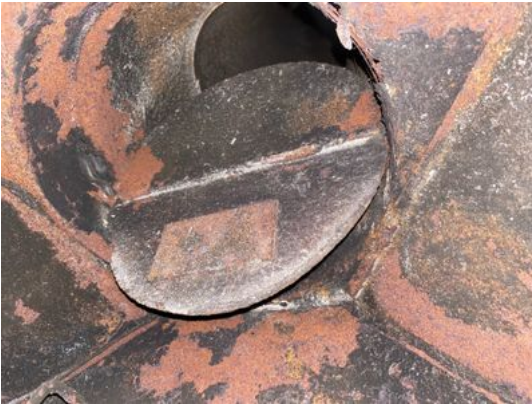
There is heavy corrosion visible on the damper and upper part of the flue. I recommend review of the fireplace by a chimney specialist and service as appropriate or approval for use in writing.

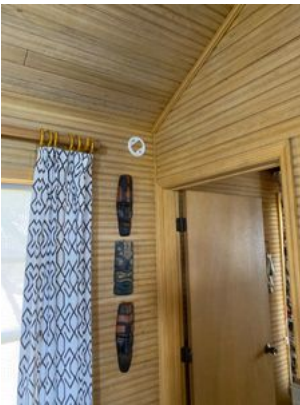
The smoke detector in the living area is missing and should be replaced.

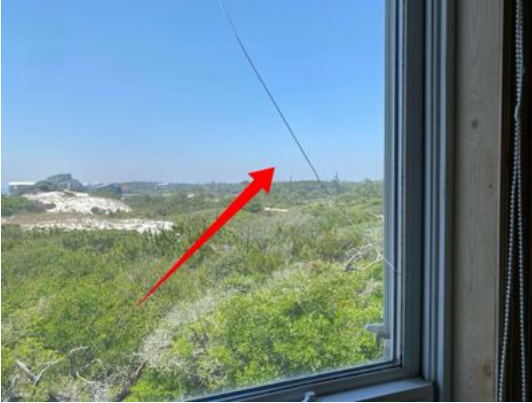
The upper glazed panel on the right side of the west wall is fractured and should be serviced.

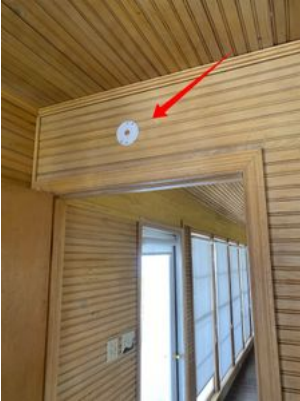
The smoke detector is missing in the SE bedroom and should be replaced to reduce potential fire safety hazard.

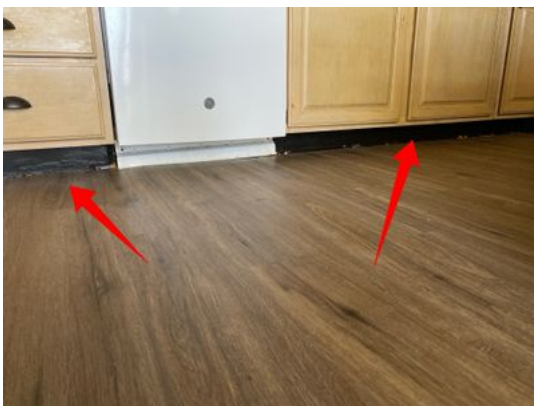
There was a damage to the toe plates on the cabinets. This is considered a WDO concern and should be addressed by the appropriate specialist.

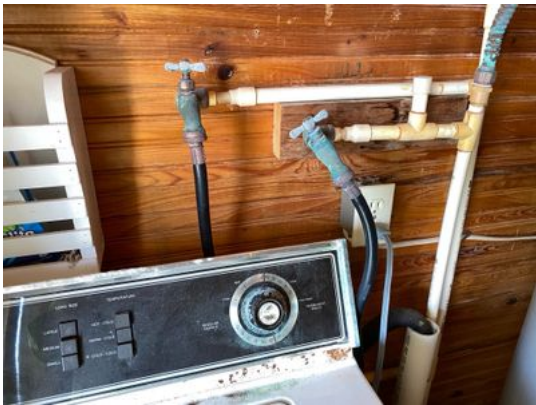
Comment 43 Information

The clothes washer discharges water to the earth. You should be aware of the condition and may wish to better manage the grey water discharge.
