4-Point Inspection Form

Address Inspected: 123 SAMPLE STREET; ST SAMPLE ISLAND, FL 32328

Date Inspected: 04/24/2024

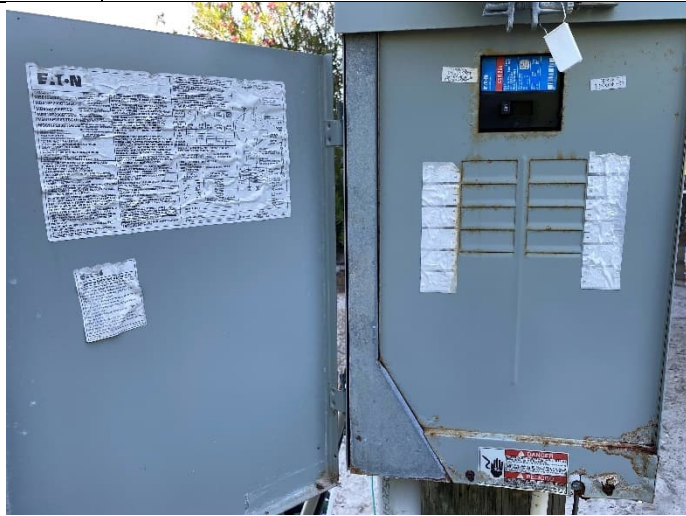
Title: Electrical panel

Notes: Brand: Eaton

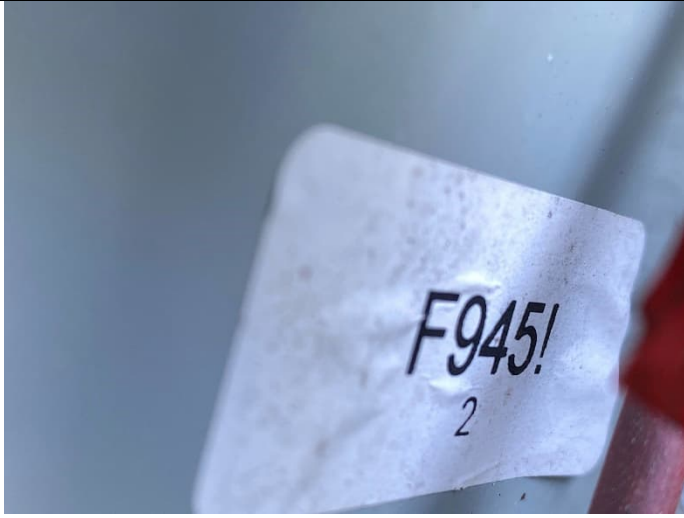
Title: Electrical panel

Notes: Eaton date code: 2019

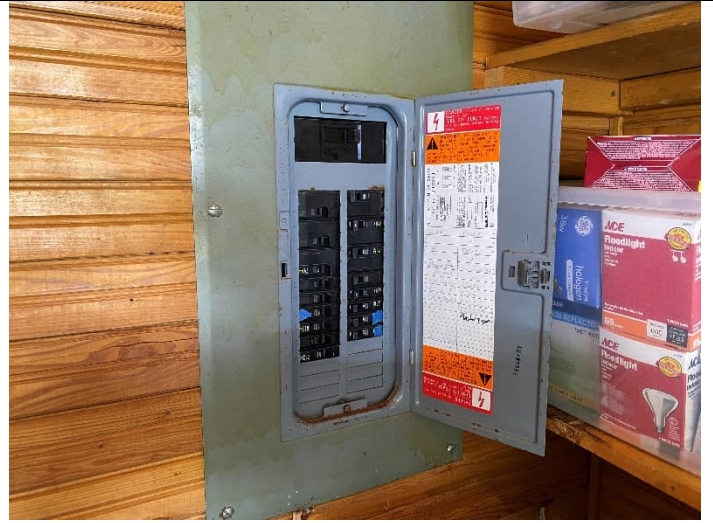
Title: Electrical panel

Notes: Brand: Square D

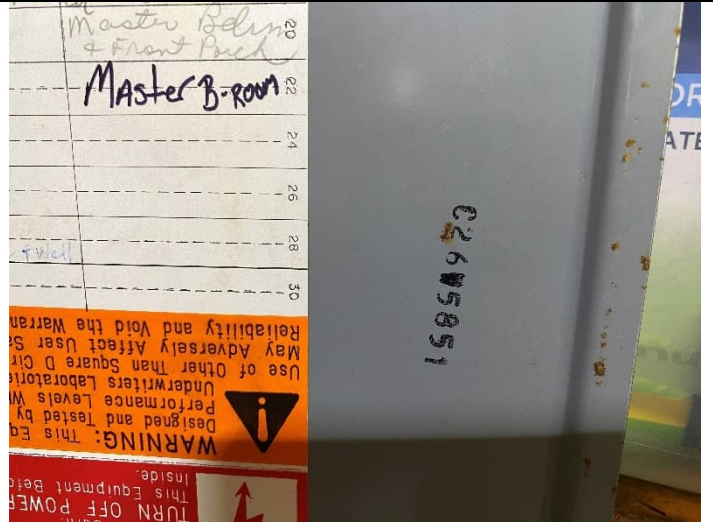
Title: Electrical panel

Notes: Square D date code: 1990

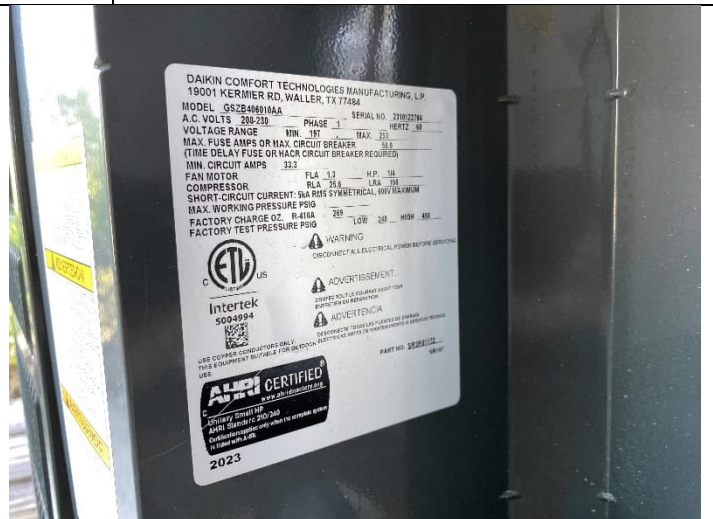
Title: HVAC

Notes: Manufactured by Goodman / Daikin in 2023

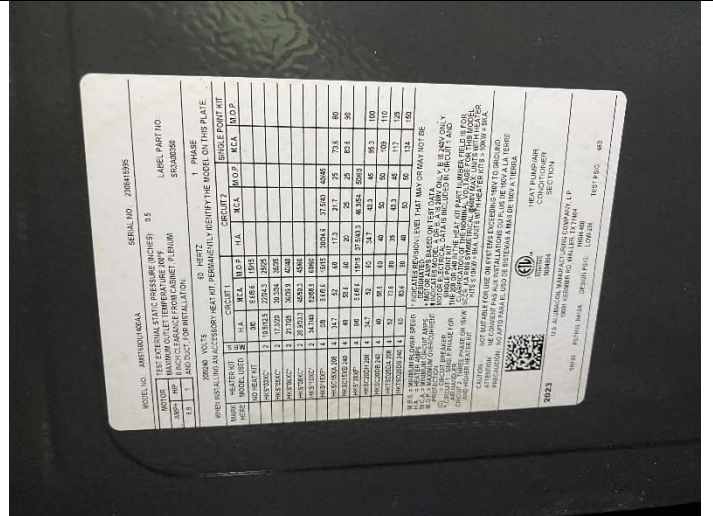
Title: HVAC

Notes: Manufactured by US Alumacoil (Daikin) in 2023

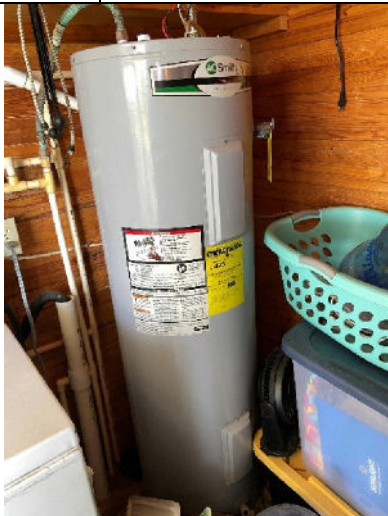
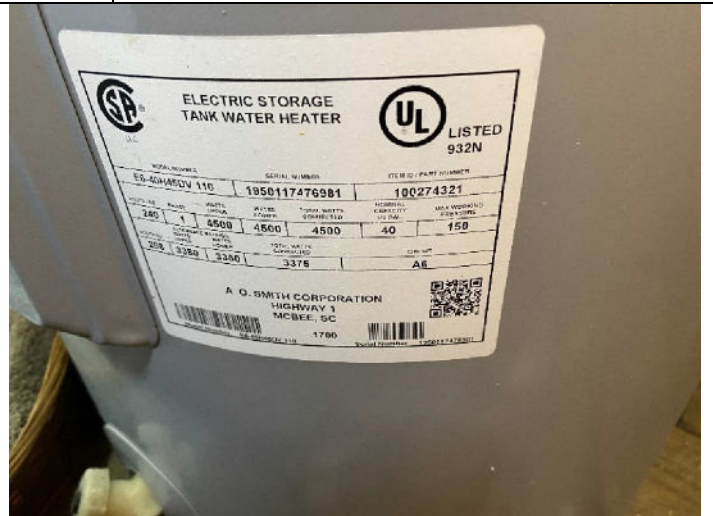
Title: AO Smith water heater mfg in 2019

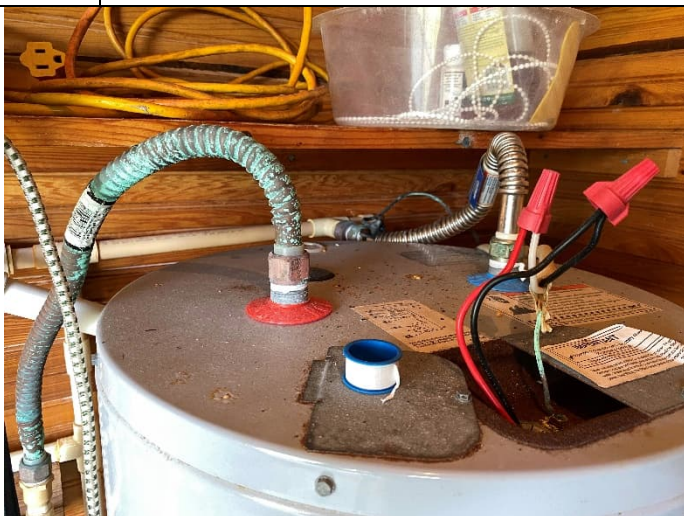
Title: Plumbing

MAIN ELECTRICAL PANEL REPLACED IN 2019
- exposed electrical connections at water heater
HVAC SYSTEM REPLACED IN 2023
WATER HEATER REPLACED 2019
ROOF REPLACED IN 2023

Notes: - Note improper wire connection
