Home Inspection Report

123 Sample Street
Sampleville, FL 32328

Prepared For: Sam Sample
Inspected On Sat, Apr 27, 2024 at 9:30 AM

The Salty Inspector
(850) 583-1717
www.SaltyInspector.com

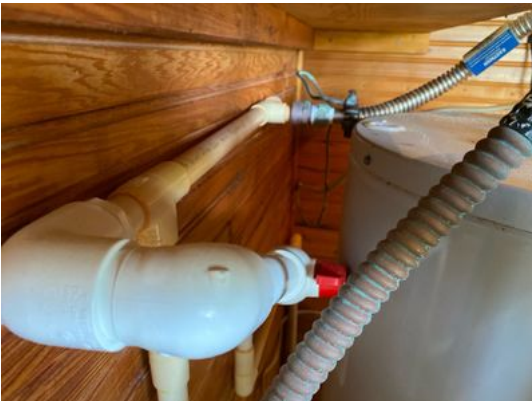
There is no water shut off valve present at the water heater, which would have been required at the time of installation. A shut off valve should be installed by a licensed plumber.

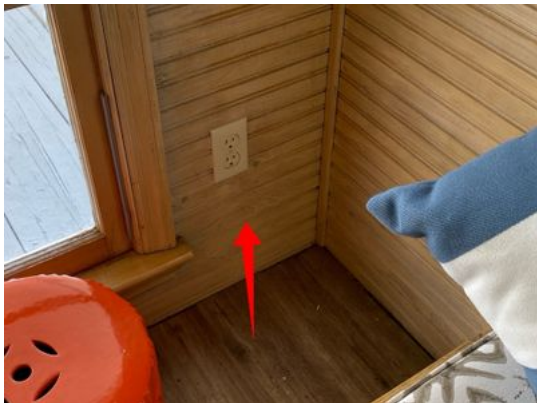
The electrical receptacle in the south west corner will not accept a plug and should be serviced to restore functionality.

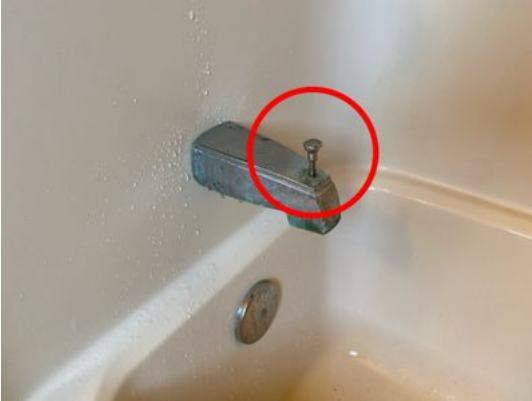
The shower diverter valve sticks in the shower position and should be serviced to release and direct water to the tub.

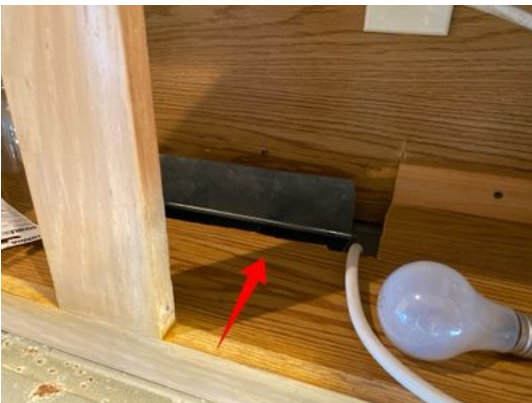
Range hood incorrectly vents into the cabinet above.

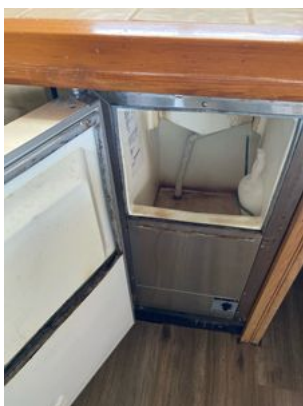
An ice maker is installed, but was not in operation at the time of inspection. The appliance should be demonstrated as functional or serviced as appropriate.

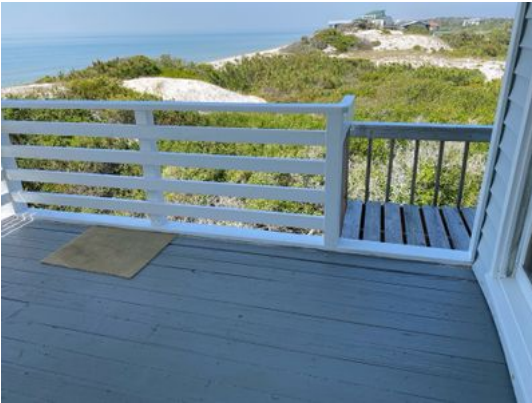
The railings around the residence are serviceable, but do not meet modern safety guidelines. Caution should be taken be used, and / or the application updated.

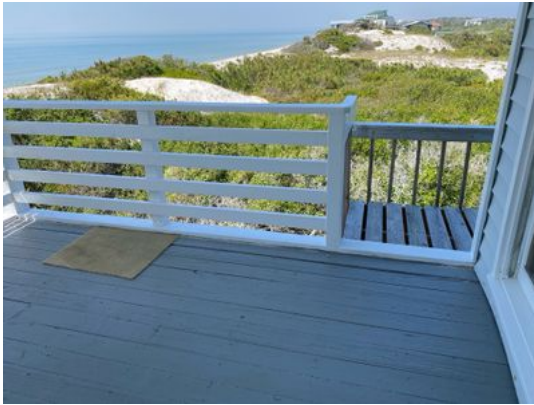
The railings around the residence are serviceable, but do not meet modern safety guidelines. Caution should be taken be used, and / or the application updated.

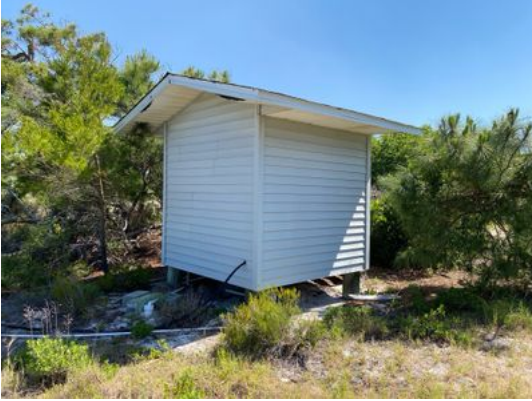
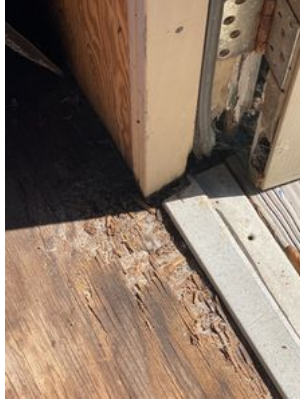
The well pump / water treatment building is in acceptable condition, with typical wear and deterioration

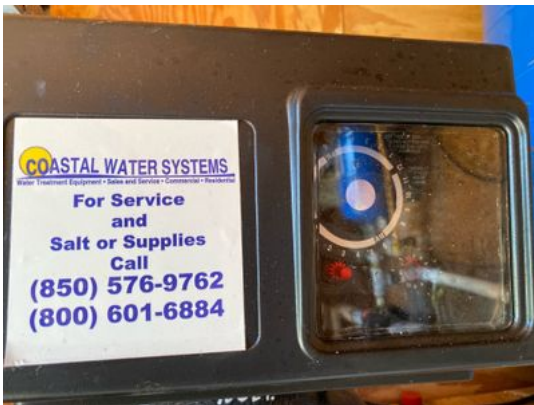
Water treatment systems are beyond the scope of my inspection. I recommend review, service and explanation of the system by a qualified professional.

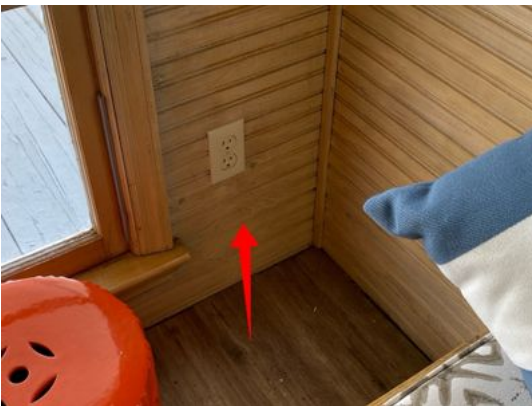
The electrical receptacle in the south west corner will not accept a plug and should be serviced to restore functionality.

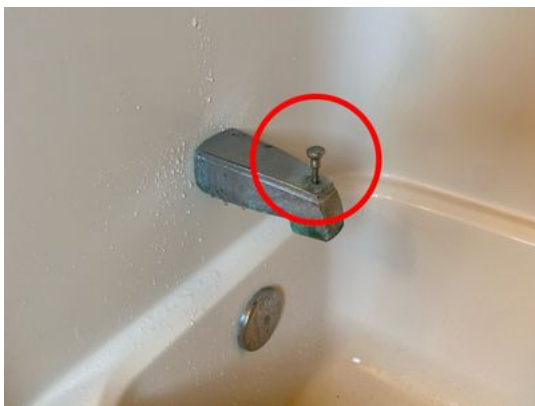
The shower diverter valve sticks in the shower position and should be serviced to release and direct water to the tub.

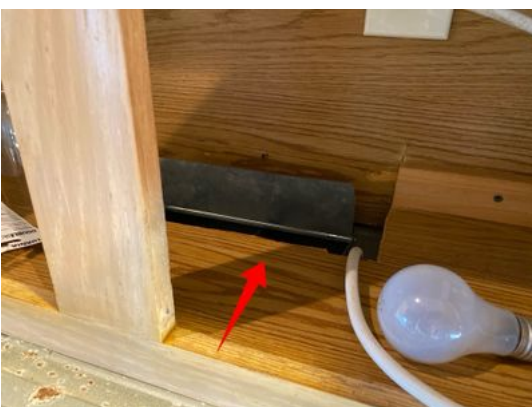
Range hood incorrectly vents into the cabinet above.

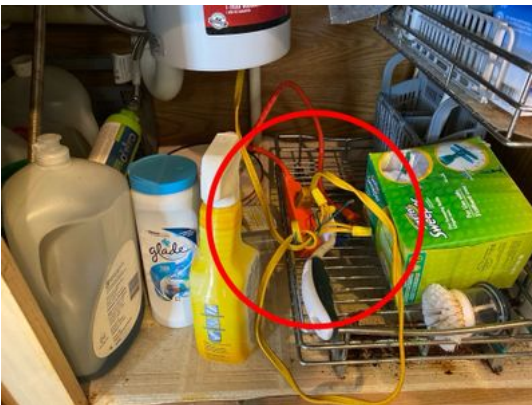
The disposable is incorrectly wired to an extension cord pig tail, and not plugged into power. This application should be corrected to restore proper operation.

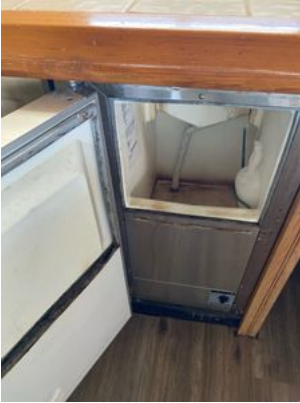
An ice maker is installed, but was not in operation at the time of inspection. The appliance should be demonstrated as functional or serviced as appropriate.

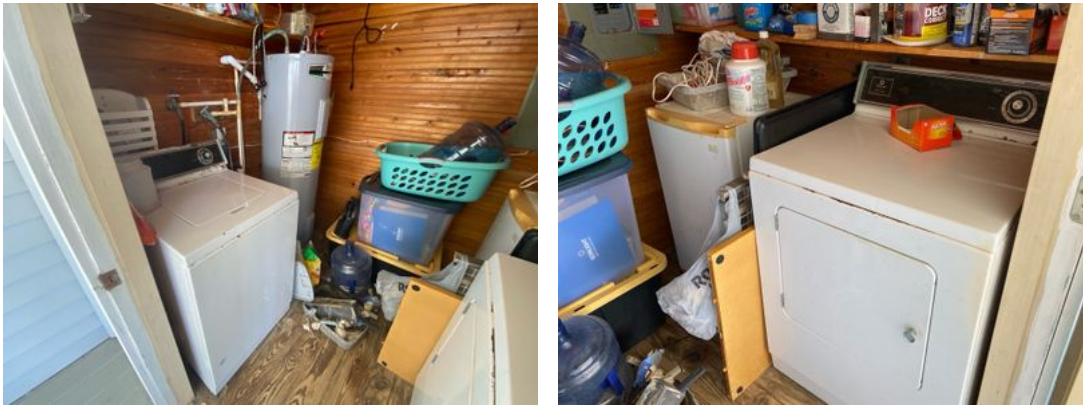
Overview Photos of Laundry

The laundry appliances were functional at inspection, but not evaluated for quality of performance. These appliances are near end of typical service life, so service / replacement should be anticipated.
